Triumph head fix

Ever since the first days of Triumph eight-stud alloy head production in the early Fifties they were prone to cracking. Engineer Len Paterson explains how they can be repaired and what's involved in fitting new valve seats

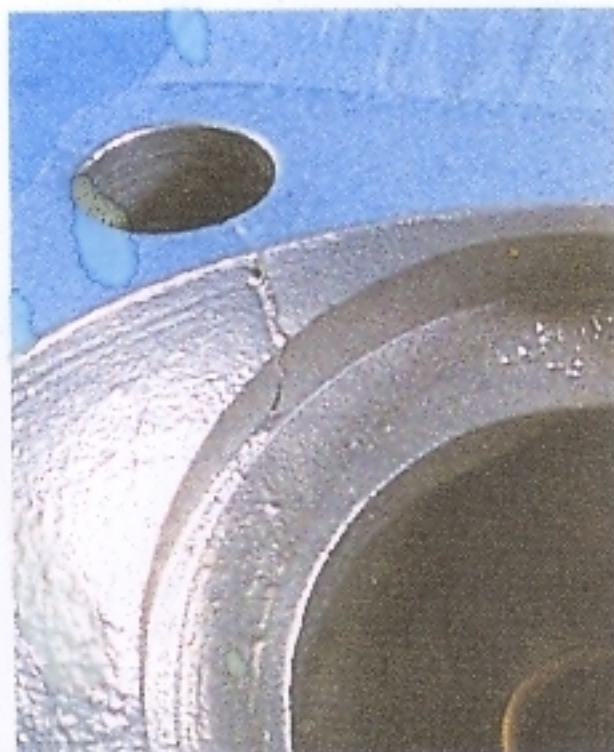
Crack in head clearly visible. See next pages for how repairs can be effected

Look at Picture 1 and you can see clearly that part of the high cast-in seat is actually forming part of the wall of the inner bolt hole. On some castings the inverted cone seat swings into the bolt hole housing, thus making

it extremely prone to cracking. Pre-unit 650 and full hemi 500 eight stud heads from 1965 to 1972 are the worst for cracks.

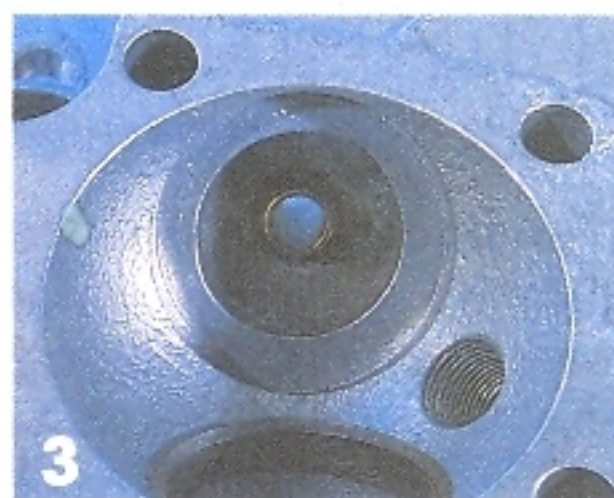
Crack between exhaust valve seat and stud has been machined away (left) ready for welding. Crack in other chamber waiting to be done

Reshape the hemispherical chambers to their original profile. Rebore bolt hole housings and reshape around pushrod tube housings if any weld has spill over, otherwise the pushrod tube will be obstructed.

Counterbore each seat housing to a maximum depth of 8mm and to a measured interference fit of a minimum of 0.0035in and a maximum of 0.0045in. Choose a lead-free material seat of 1.5mm - 3mm bigger than the valve you are using.
