Triumph head fix

Ever since the first days of Triumph eight-stud alloy head production in the early Fifties they were prone to cracking. Engineer Len Paterson explains how they can be repaired and what's involved in fitting new valve seats

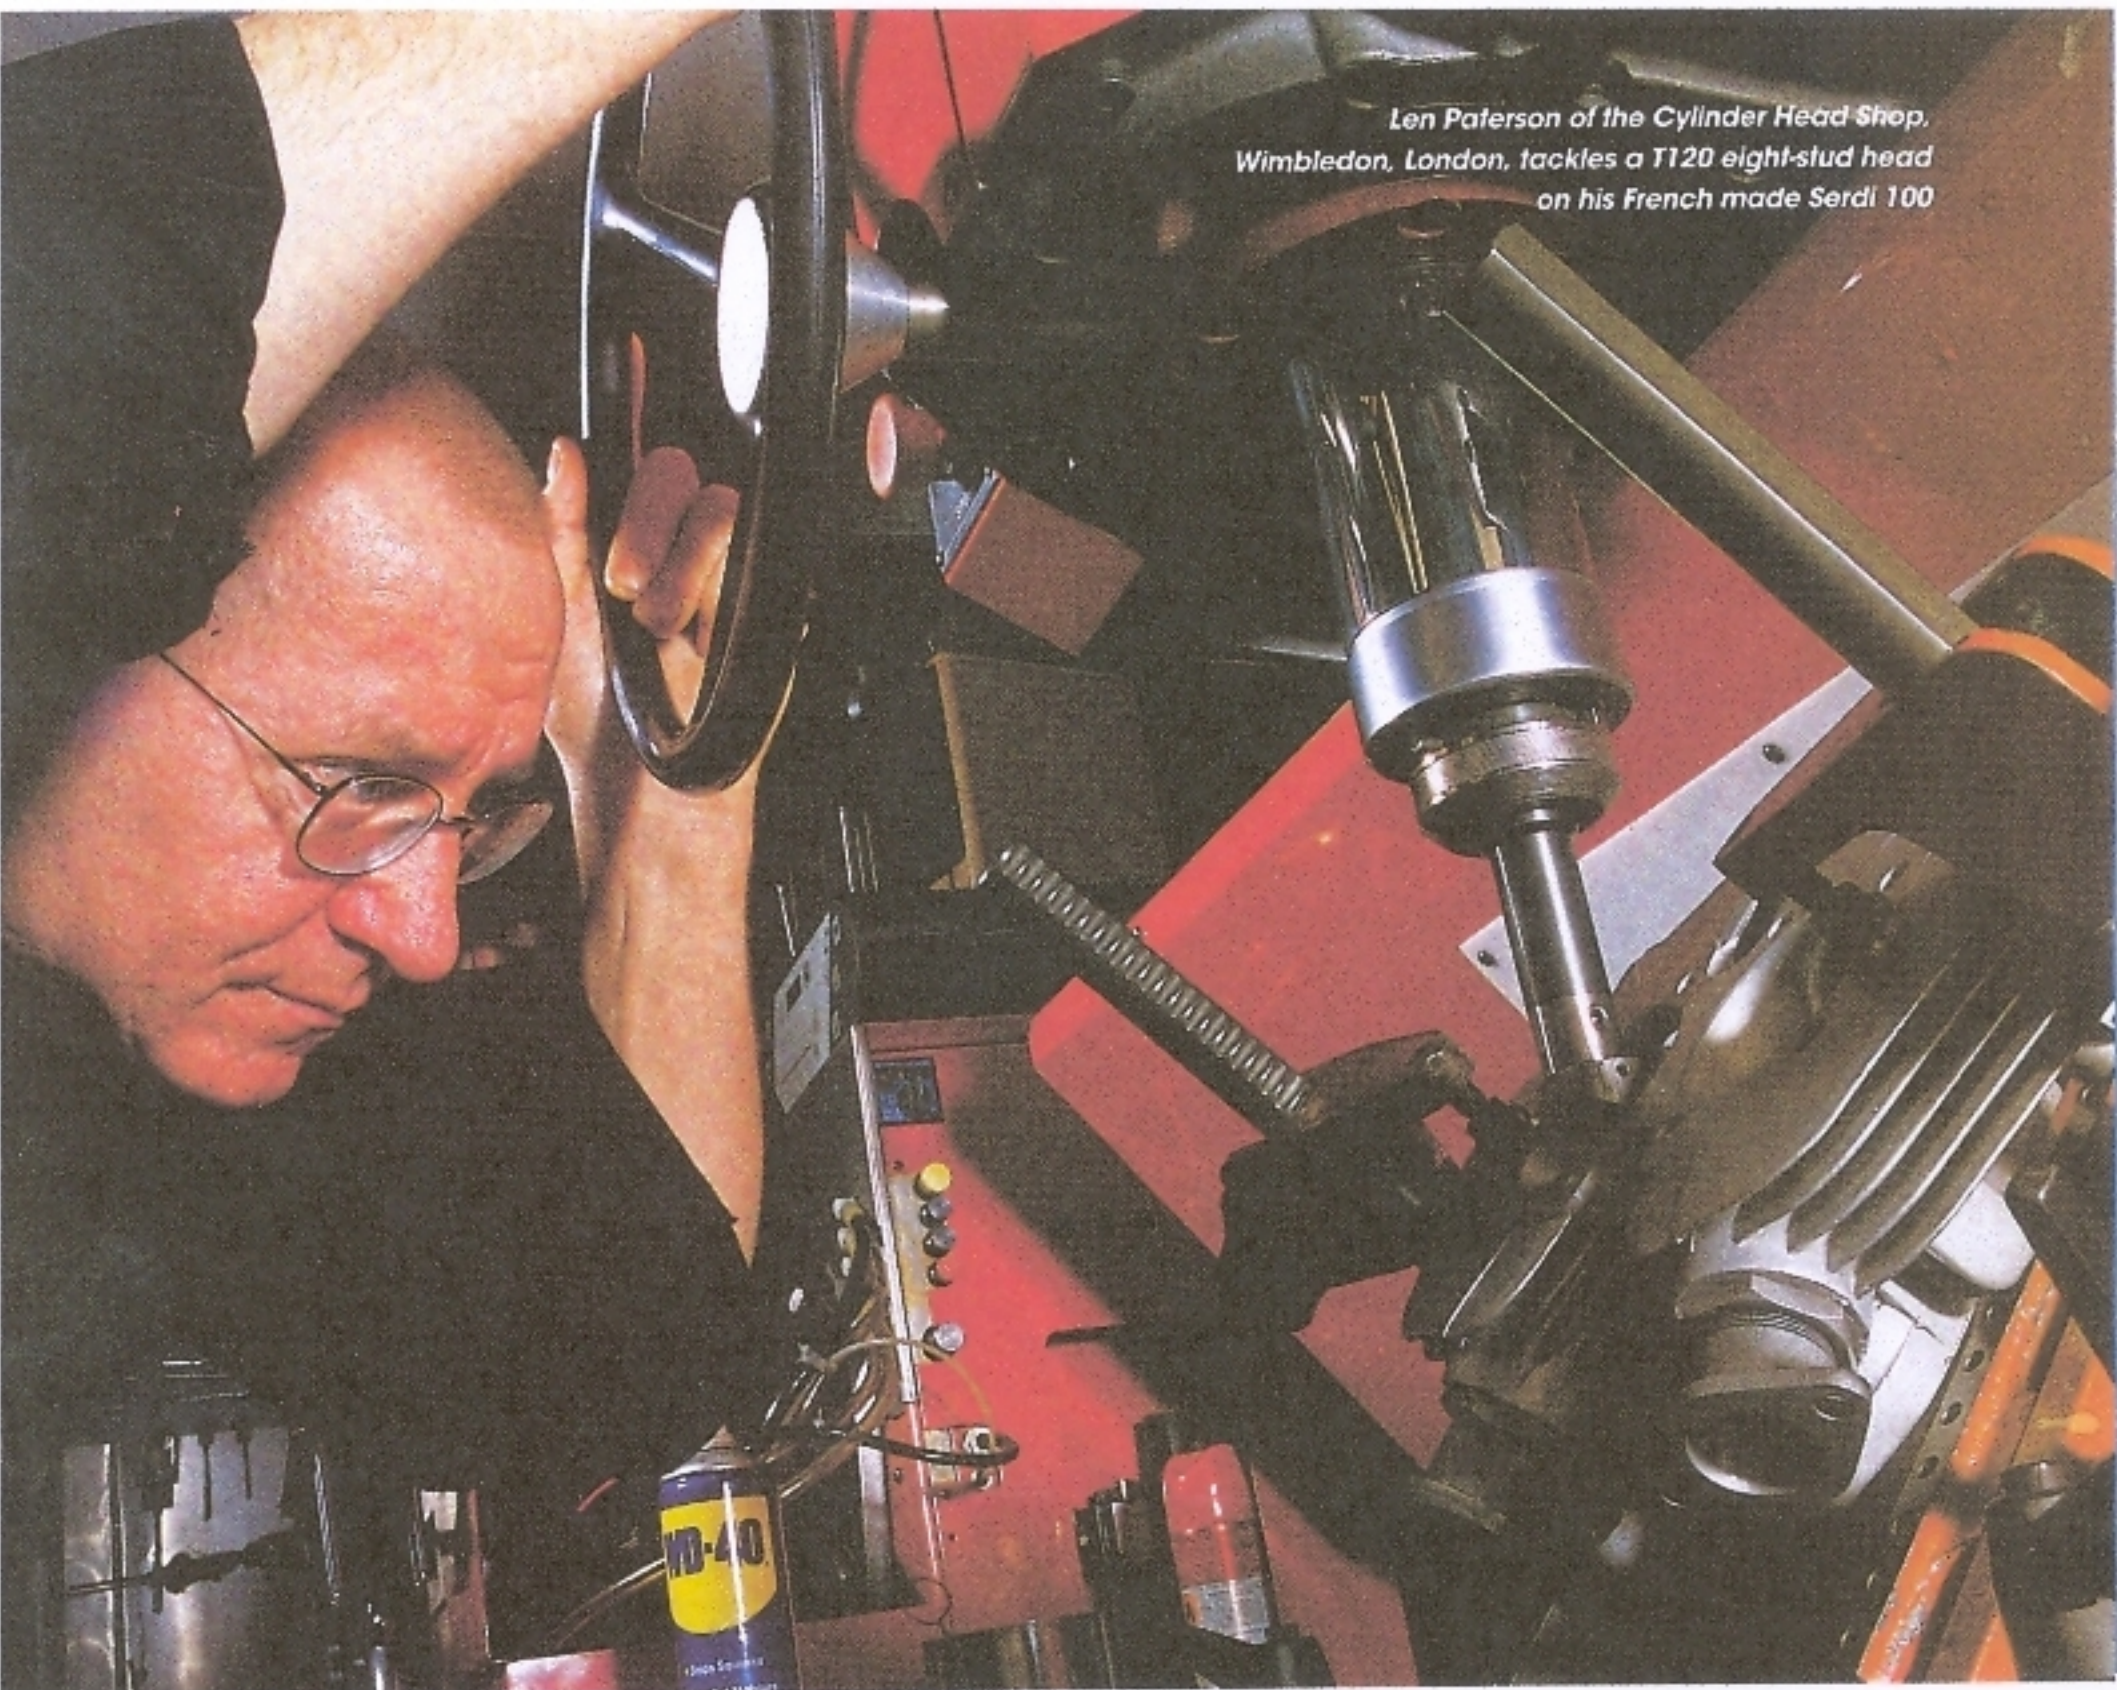
Len Paterson of the Cylinder Head Shop, Wimbledon, London, tackles a T120 eight-stud head on his French made Serdi 100

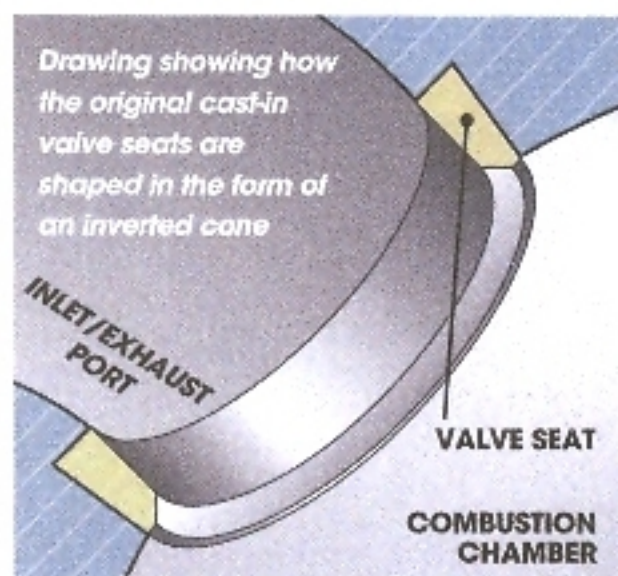
Look at Picture 1 and you can see clearly that part of the high cast-in seat is actually forming part of the wall of the inner bolt hole. On some castings the inverted cone seat swings into the bolt hole housing, thus making

it extremely prone to cracking. Pre-unit 650 and full hemi 500 eight stud heads from 1965 to 1972 are the worst for cracks.

Machine or grind out all four cast-in seats. Remove all traces completely. Do all four seats even if they are not all cracked because the heat of welding can tip the balance on those that are borderline.

Prepare cracks for welding by cutting as far as possible into the crack with a carbide or HSS cutter. Don't use a stone cutter because it can contaminate the alloy in some cases. Vapour blast or bead blast or chemically clean all areas to be welded.
